THAMES RIVER BASIN
MANSFIELD-WINDHAM, CONNECTICUT

WILLIMANTIC RESERVOIR DAM
CT 00198

PHASE 1 INSPECTION REPORT
NATIONAL DAM INSPECTION PROGRAM

JUNE 1979

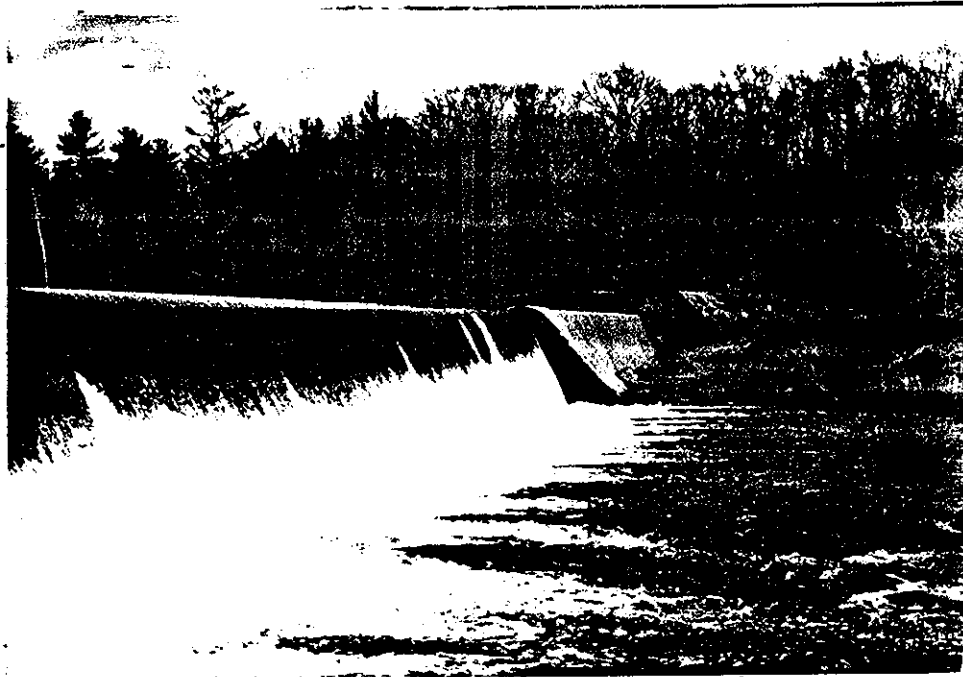
C-1 Downstream face of Dam looking from right abutment.

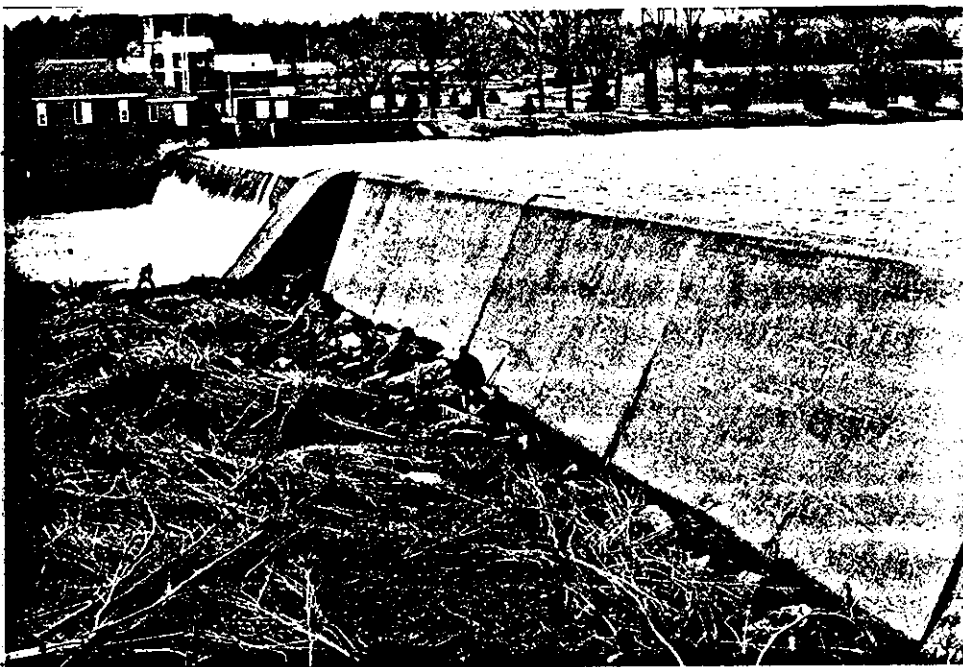
The downstream channel, shown in Photo C-2, appears to be in generally good condition. The left side of the downstream channel appears to have been recently cleared of vegetation as shown in Photo C-2. A pile of cut stone blocks was noted at the downstream toe of the left spillway section.

C-2 Downstream face of Dam looking from left abutment.

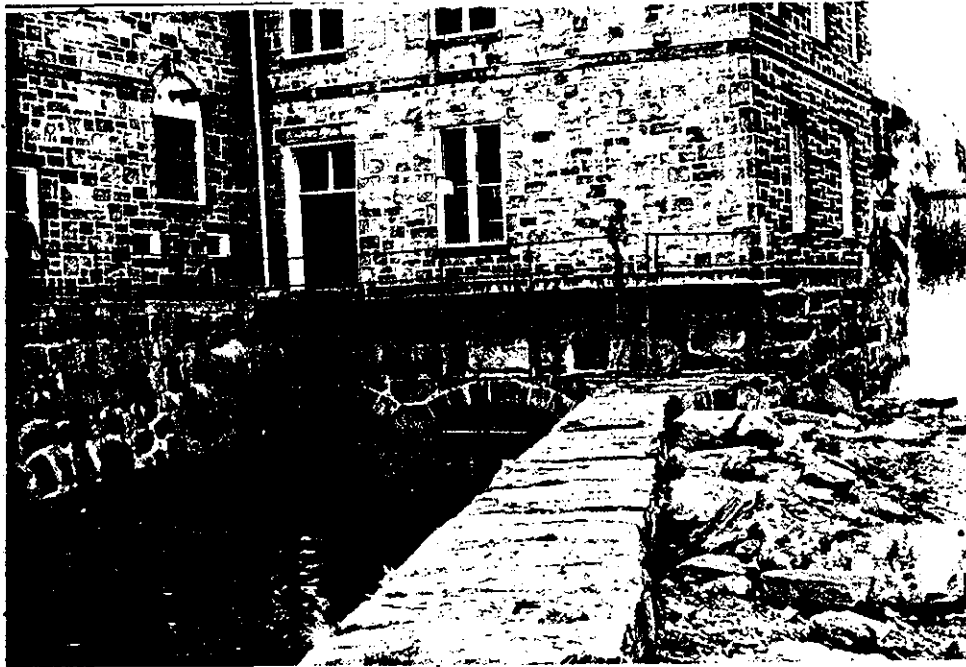
C-3 Pumping Station and Tailrace.

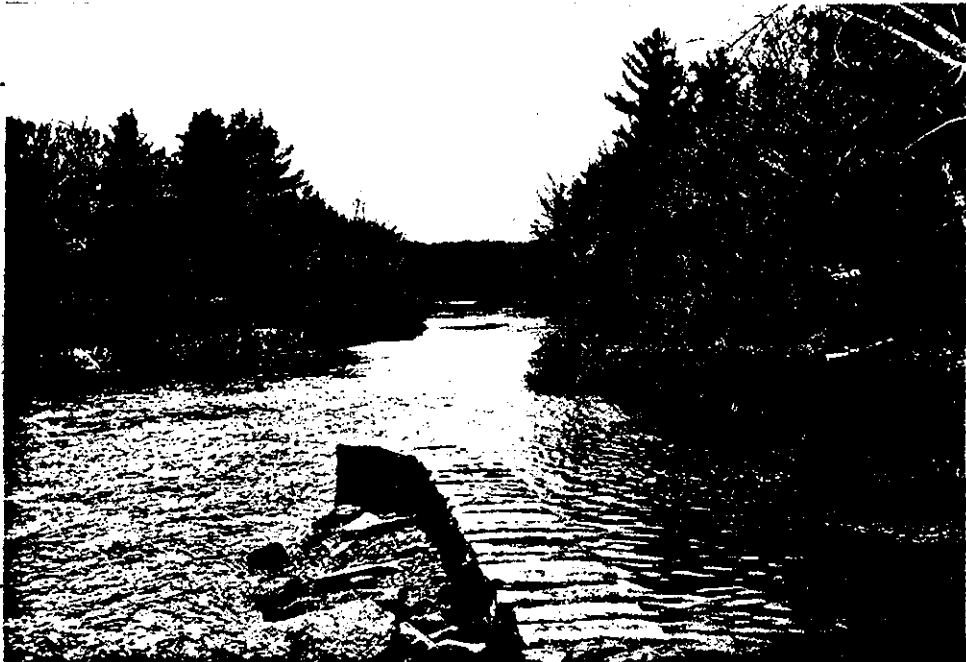
C-4 End of Pumping Station Tailrace and Nachaug River
Downstream.

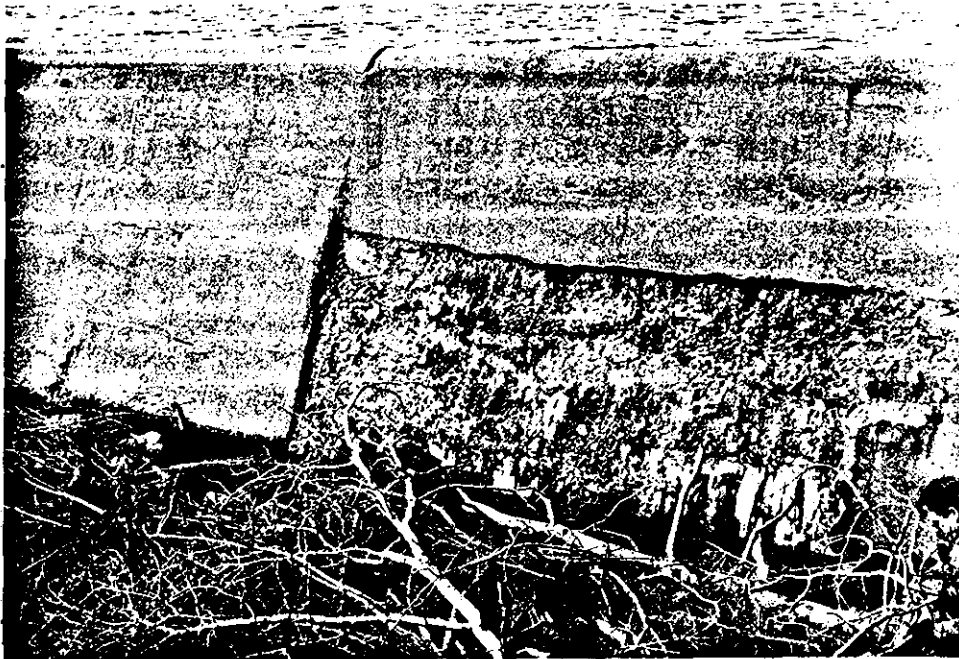
The downstream face of the left section of the spillway is badly spalled.

A small pool of water was observed at the downstream toe of the left spillway section. It is unclear whether this water is from seepage below the dam or run-off from the left abutment area. An area of spalled concrete was noted on the downstream face of the left spillway section, as noted in Photo C-5. Slope erosion has occurred adjacent to the left spillway training wall.

1. The concrete on the downstream face of the left section of the spillway is badly spalled.

C-5 Spalled Concrete Face of Overflow Spillway.

The downstream face of the left spillway section is badly spalled and should be rehabilitated.

1. Develop a system for the recording of data with regard to items such as water levels, discharges, to assist those responsible for the monitoring and operation of the structure.
2. Implement a program to clear the discharge channel of vegetation in order to increase the efficiency of the outlet and removal of brush and trees piled downstream of the left section of spillway.
3. Continue the technical inspections of this facility on bi-annual basis.
4. Develop and post an emergency action plan including a warning system in order to prevent or minimize the impact of dam failure. It should include the expedient action to be taken, authorities to be contacted, and locations of emergency equipment and materials.
5. Repair all spalled concrete.
